CASE REPORT**PATHOLOGY/BIOLOGY: ENGINEERING SCIENCES**

Massive Lesions Owing to Motorcyclist Impact Against Guardrail Posts: Analysis of Two Cases and Safety Considerations*

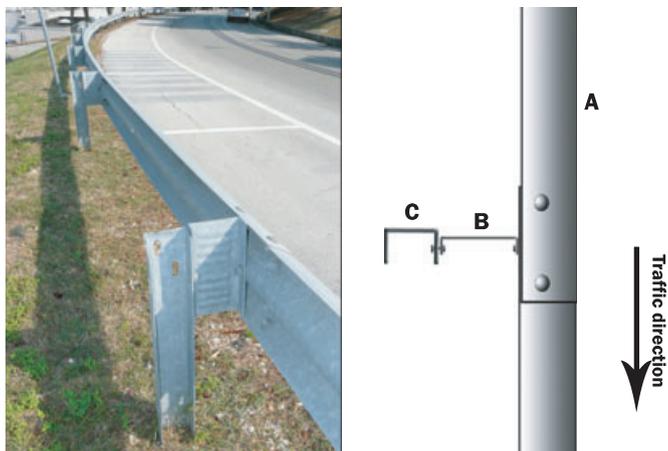
FIG. 1—Guardrail: photograph and schematic view from above. A = beam; B = distancer; C = □-shaped post.

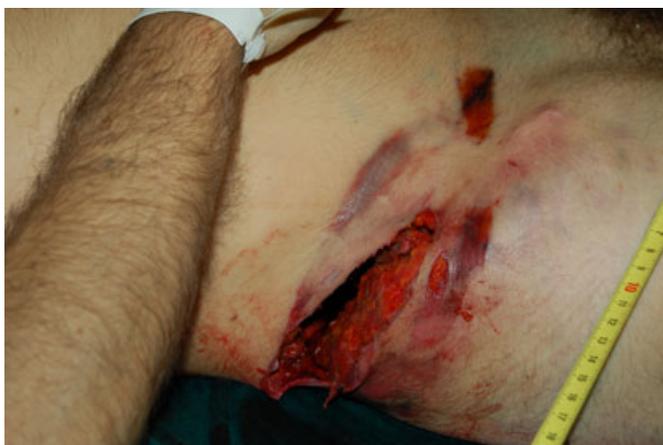
The physical examination demonstrated a broad, transverse, abraded, and contused band-like lesion involving the right lumbar area and hip. Two long, parallel tracks separated by ca. 8 cm deeply marked the skin, which exhibited a severe, extensive laceration with irregular and ragged margins that exposed the underlying soft tissues and bones (Fig. 2). The pelvis and left leg were fractured. The cause of death was attributed to severe, irreversible hemorrhagic shock because of massive bleeding from a large, open fracture wound involving the pelvis and adjacent soft tissues.

FIG. 2—Case 1. Note the two long, parallel tracks and the extensive laceration.

Analysis of the first victim's lesions allowed the accident dynamics to be reconstructed as follows: after falling off the bike, the man slid on the asphalt at a 40–45° angle and hit the guardrail post face with the right hip. The lesion characteristics were consistent with the width of the post. The high-energy impact produced the abraded contused lesion and the soft tissue laceration between its tracks (Fig. 5).

It is conceivable that such guardrails would have prevented the fatalities described earlier. In case 1, even though the angle of the impact was fairly wide (40–45°), the kinetic force was not very high. The high energy of the impact of case 2 was associated with an angle of only 30°. A guardrail beam reaching down to the road surface would have prevented the impacts with the posts, which were responsible for the fatal lesions.

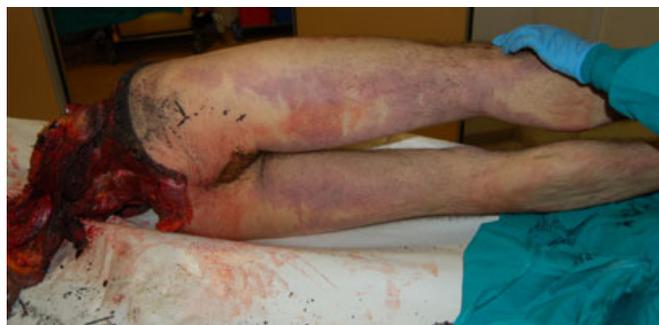
FIG. 3—Case 2. Note the exposed whole lumbar spine, still attached to the lower half-body.

paravertebral muscles, and perispinal soft tissues were resected at a more cranial level (T12); therefore, the whole lumbar spine was still attached to the lower half-body and was exposed (Fig. 3). In particular, vertebra L5 was normally joined to the pelvic bones. Some of the abdominal organs were still attached to the lower half-body. A distinctive patterned lesion was noted at the level of the postero-inferior portion of the chest, which consisted of two transverse, parallel, band-like abraded contused lesions 3 cm in thickness, running at a distance of ca. 12 cm across the width of the chest (Fig. 4). The lower lesion coursed at the level of T12 and of the spinal resection.

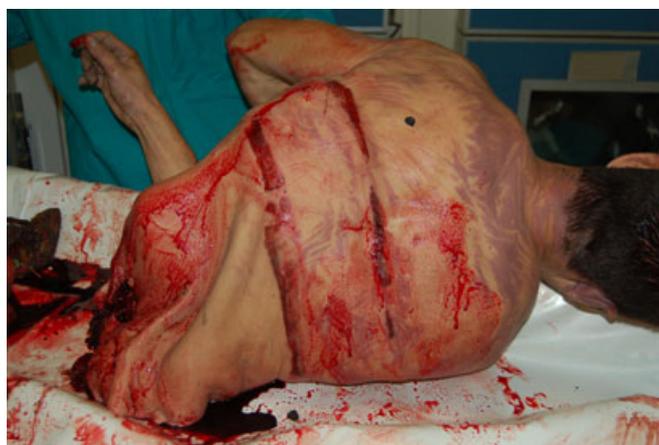
FIG. 4—Case 2. Note the two transverse, parallel, band-like, abraded contused lesions.

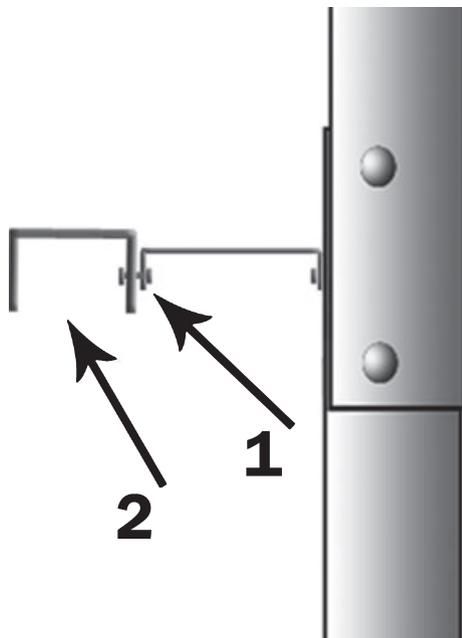
Examination of the injuries sustained by the second victim suggested that the body, after skidding toward the margin of the road across the two lanes, roughly at a 30° angle, as determined onsite, impacted the open profile of the guardrail post with the back (Fig. 5). The characteristics of the back lesion, consisting of two identical parallel tracks running 12 cm from one another, were

FIG. 5—Case 1 and case 2: impact angle and direction.

consistent with the \square shape of the guardrail post. The high-energy impact resulted in resection of the spine at the level of T12 and tearing of the soft tissues at the sites of least resistance, owing to the high kinetic force and the absence of retaining osseous structures. The body was cut roughly into two halves at the boundary between the abdomen and the lower limbs.

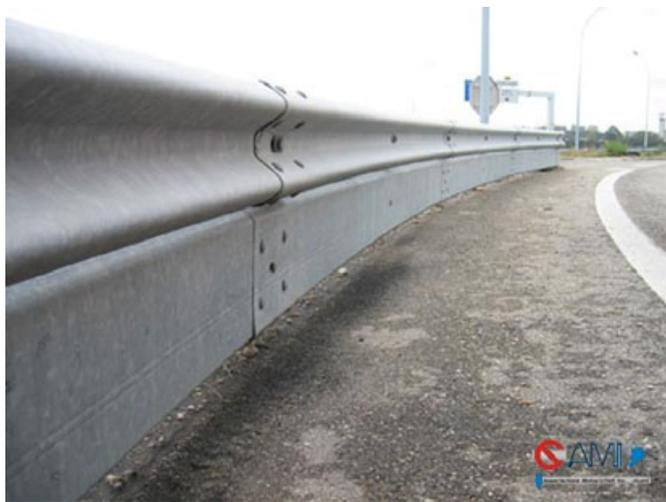
FIG. 6—Guardrail manufactured in France. Source: AMI, Associazione Motociclisti Incolumi.
